OROVILLE SPILLWAY REPAIRS

OCTOBER 2017

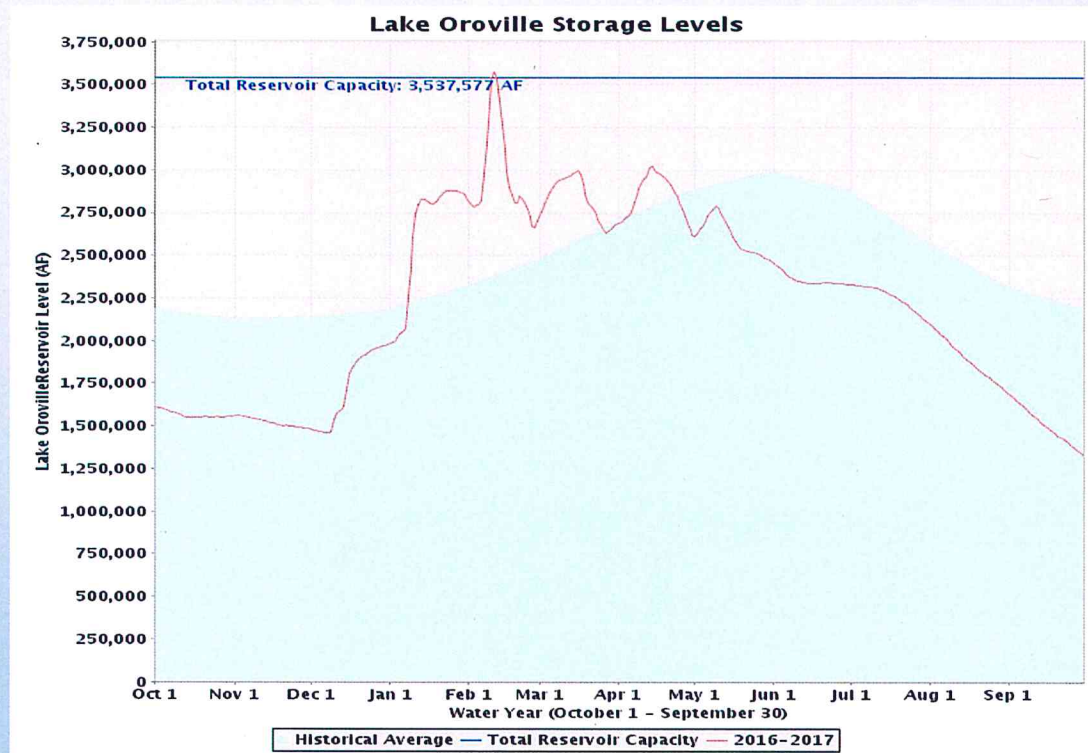
OROVILLE GAINS 2.5 MILLION ACRE FEET IN 5 WEEKS

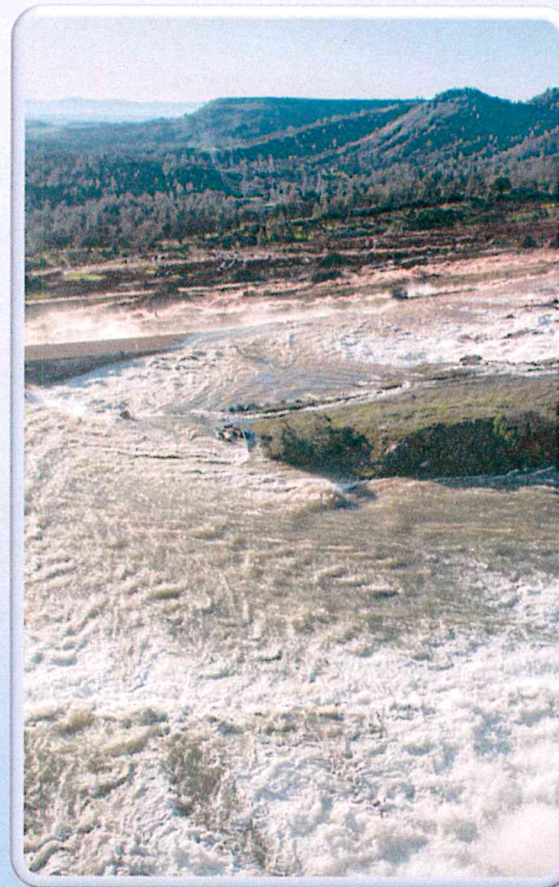
FEBRUARY 11TH

AS THE LAKE SURFACE ELEVATION REACHES 901 FEET
AT 8 AM THE EMERGENCY SPILLWAY BEGINS SPILLING
WATER FOR THE FIRST TIME SINCE IT WAS COMPLETED
IN 1968

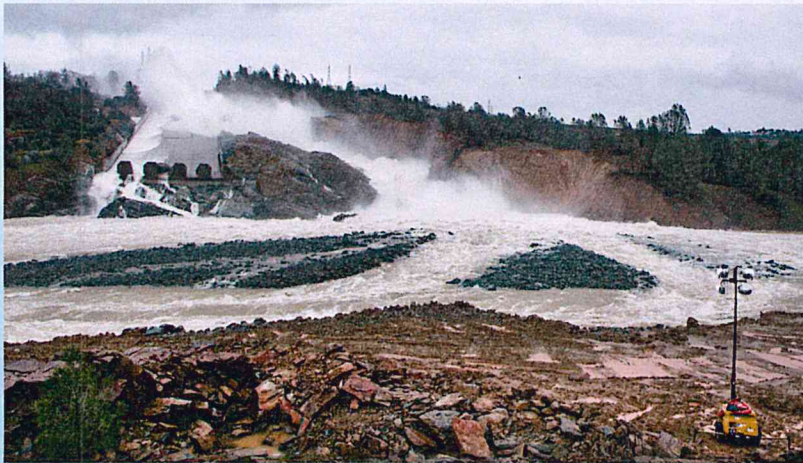
FEBRUARY 27

DEBRIS PILE UP FROM DAMAGED SPILLWAY AND HILLSIDE EROSION LIMITING RELEASES FROM HYATT POWER PLANT DUE TO BLOCKAGE OF RELEASE WATER THROUGH THE AFTER BAY

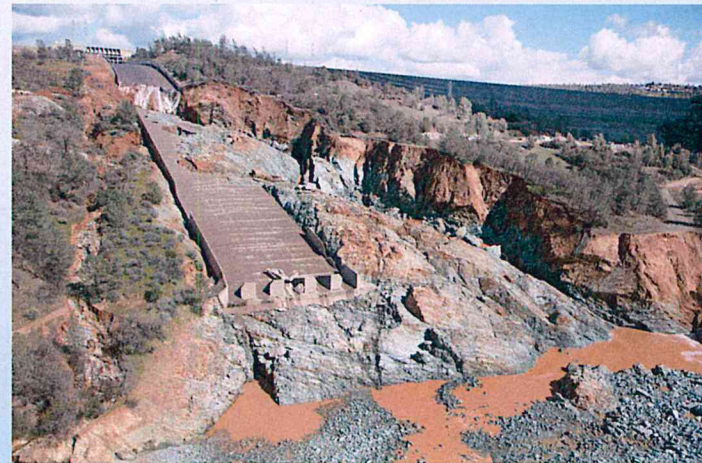
FLows FROM MAIN SPILLWAY ARE SHUT-OFF AND REMOVAL OF SPILLWAY DEBRIS BEGINS

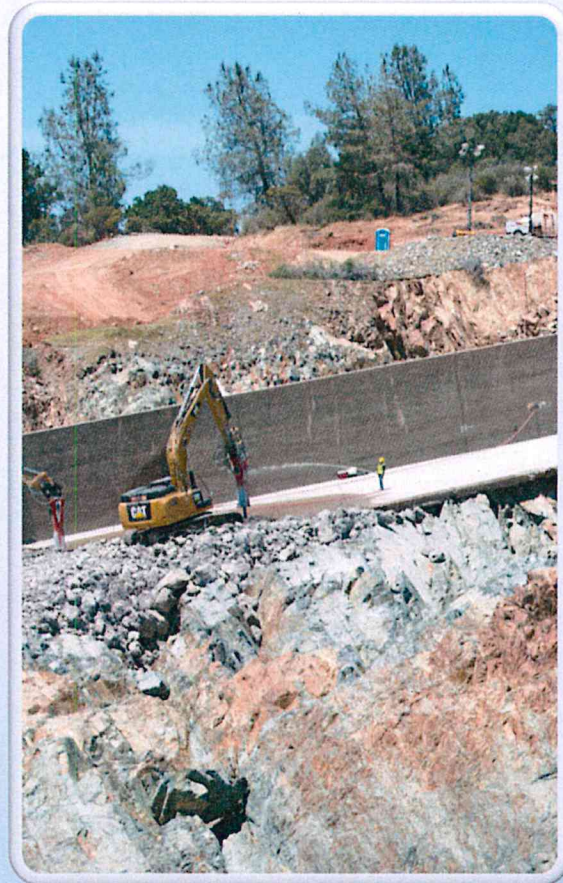
**AUGUST 23 MAIN SPILLWAY
LOWER CHUTE DEMOLITION WAS
COMPLETED**

**DEMOLITION BEGAN ON APRIL 22
WITH CONTROLLED BLASTING AND
CLEARING OF THE SPILLWAY**

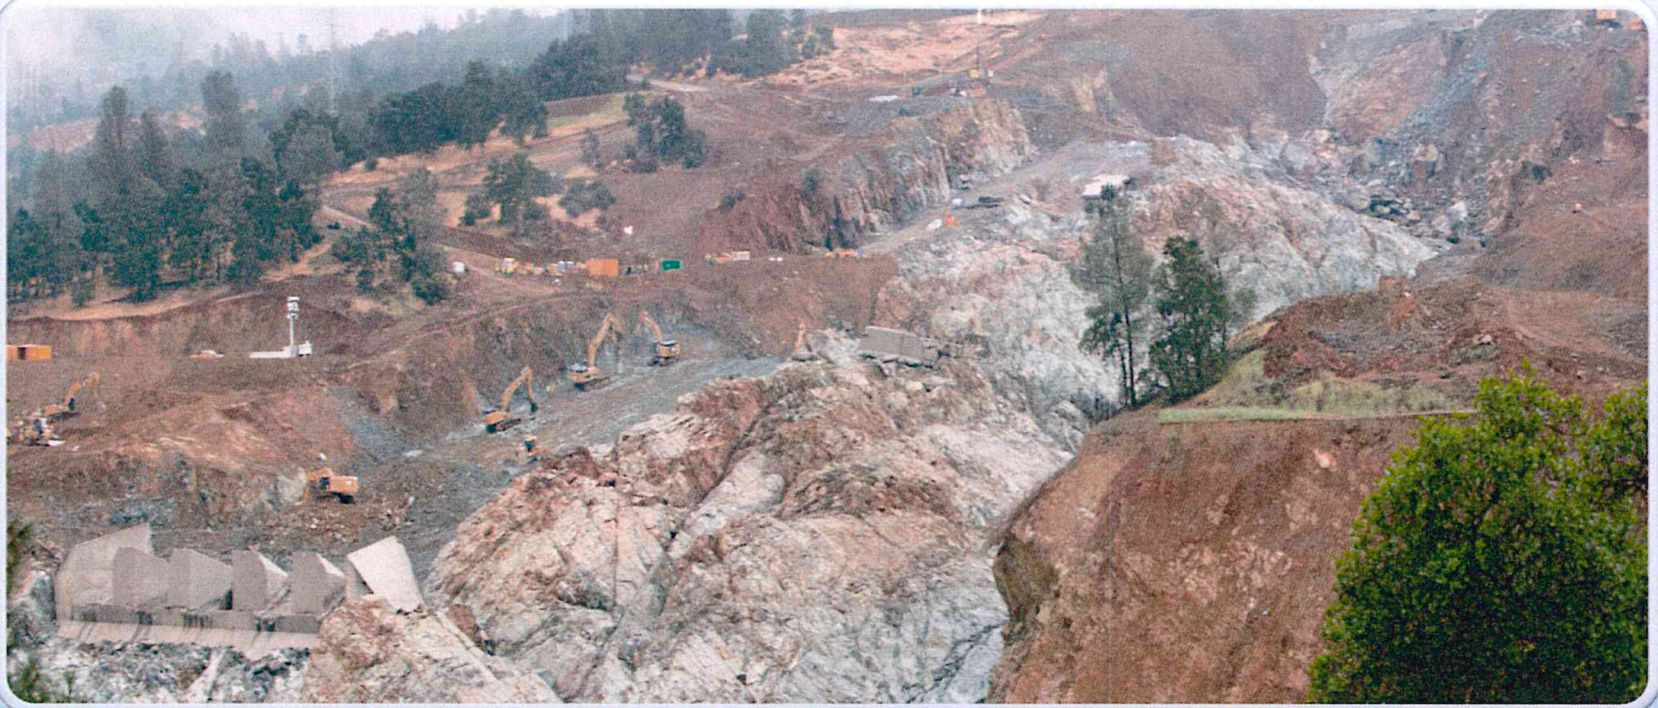
COMPLETED REMOVAL OF LOWER SPILLWAY SECTION

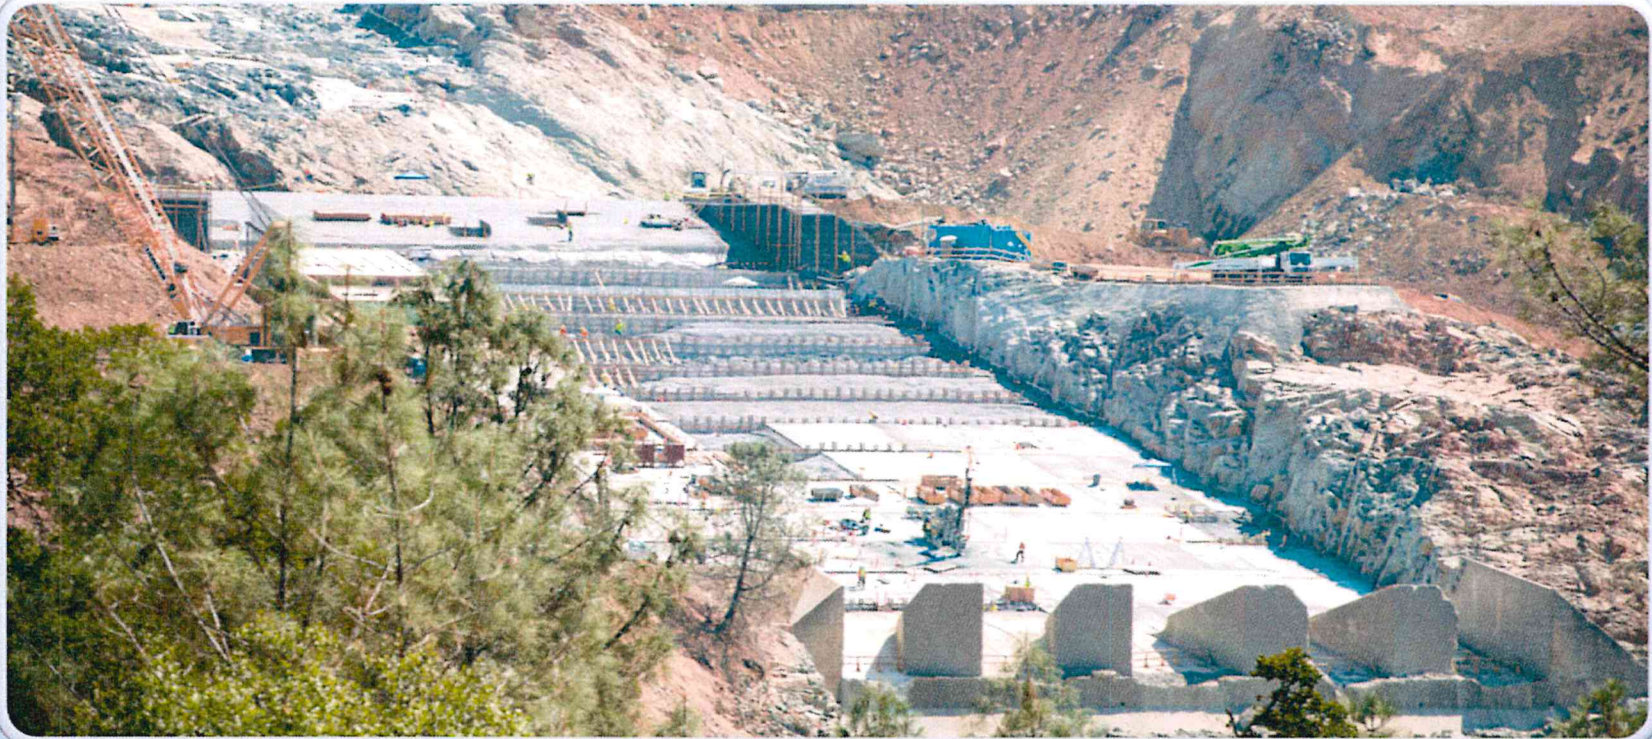
RECONSTRUCTION OF LOWER SPILLWAY

STRUCTURAL AND LEVELING CONCRETE IS PLACED NEAR THE BOTTOM OF THE LOWER CHUTE

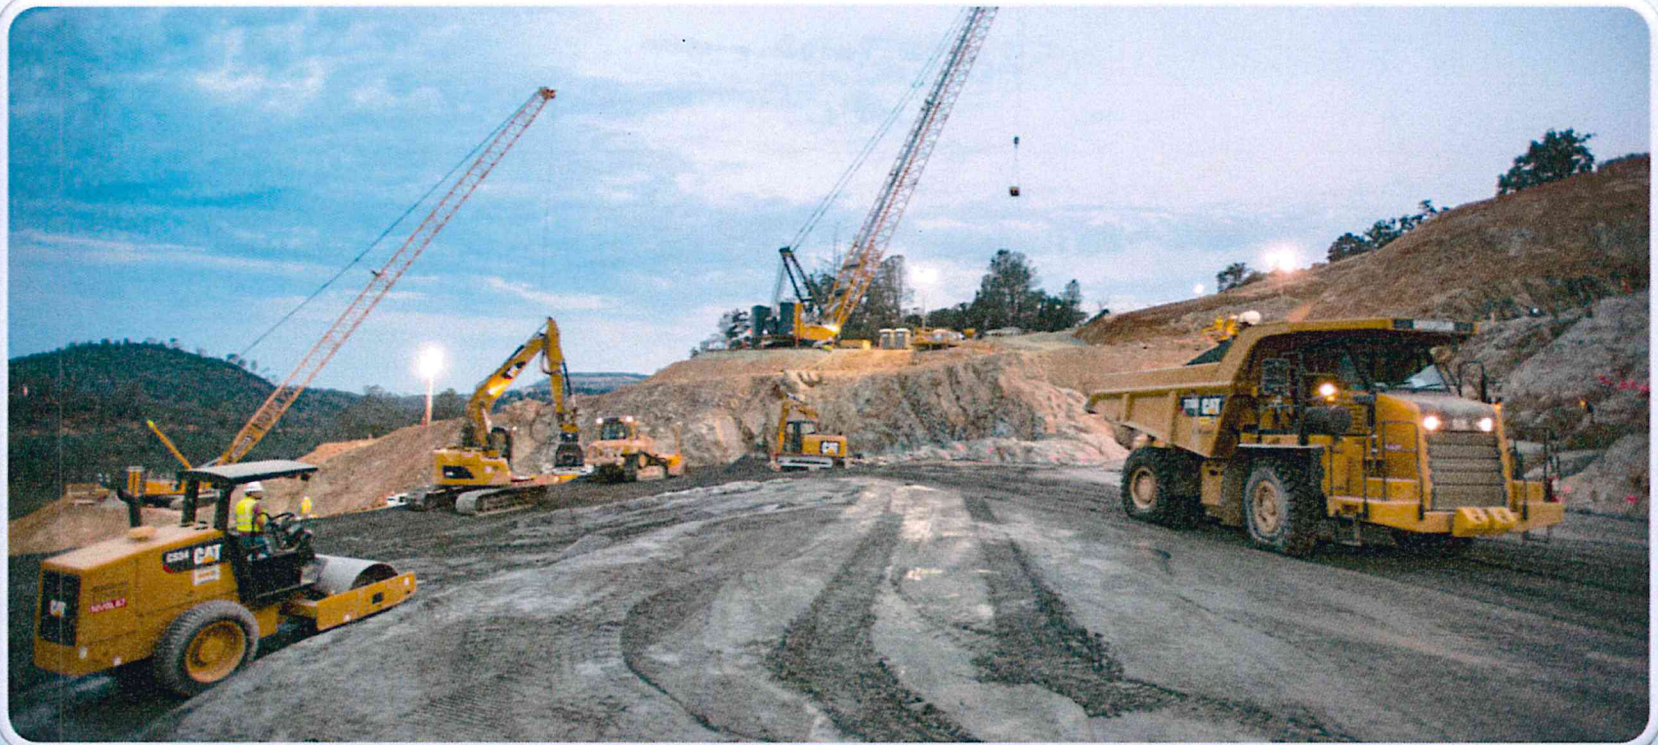
ROLLER COMPACTED CONCRETE PLACED IN AREA OF EROSION

313,000 CU YARDS
ROLLER COMPACTED CONCRETE TO FILL BREACH
